REPAIR OF SAMSUNG SyncMaster 204T MONITOR FLICKER PROBLEM

By: Doug Johnson

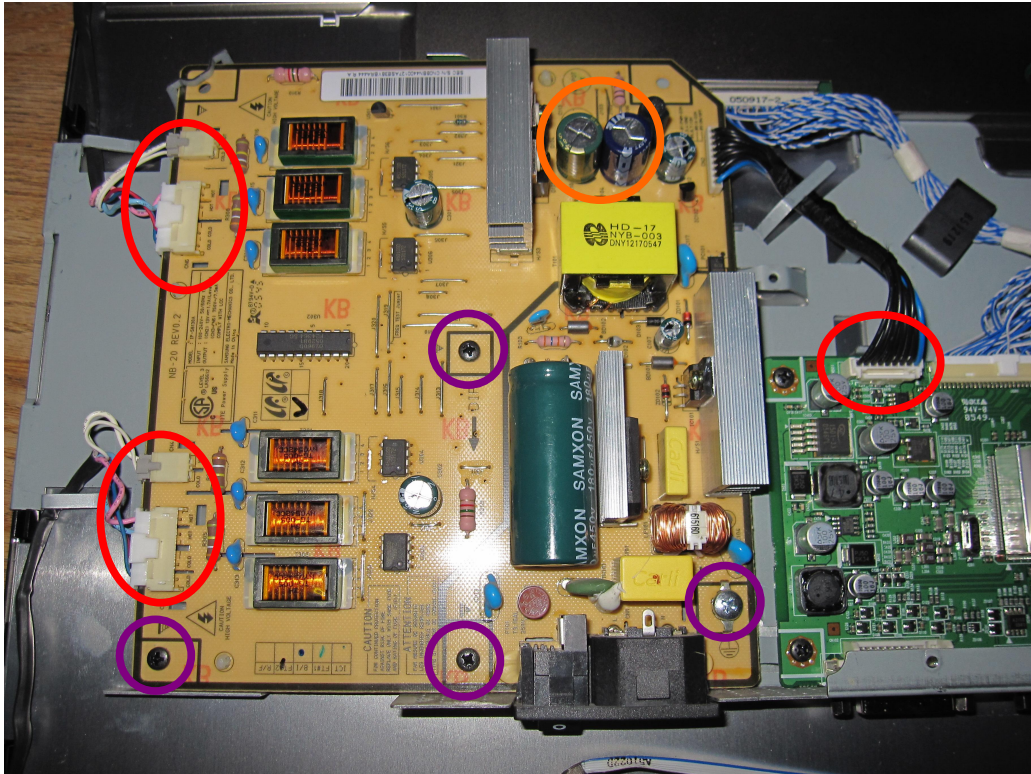
On right -- Green in color -- is the video board. While it can cause flicker, it's not likely the problem.
On left -- Yellow in color -- is inverter board, which powers the backlighting for the monitor.

Remove yellow / left / inverter PCB

- 4 screws [purple circles]
- 5 connectors [red circles]

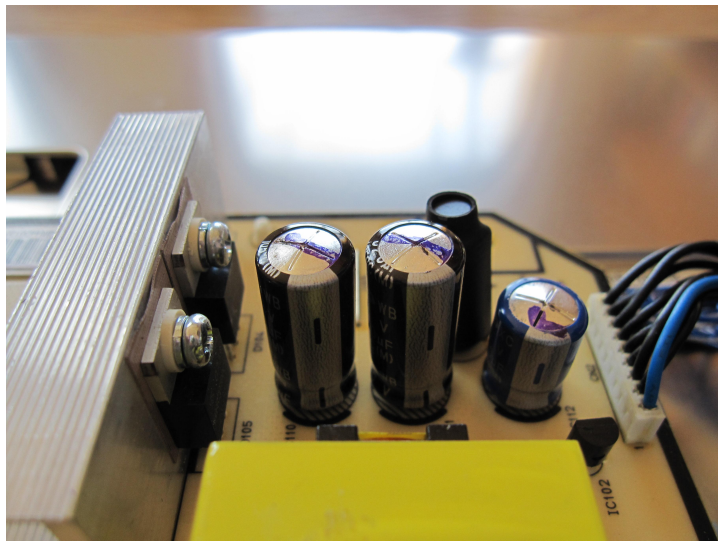
Closeup view.

The problem capacitors -- C110 & C111 -- are in upper left corner [orange circle]

Note: On two occasions of making this repair, the original equipment 820uF capacitors had obvious signs of stress as indicated by swelling at the top and bottom of the cans.

Unsolder and replace C110 and C111.
Be mindful of polarity.

Note: My local parts house did not have the requisite 820uF @ 25V electrolytics. So after some thought I simply purchased 1 each 680 uF and 1000 uF components. The two are wired in parallel [one can easily see the PCB trace], so the resulting 1680uF will have approximately the same impedance and joule storage as the original 1640uF
