REPAIR OF SAMSUNG SyncMaster 204T MONITOR FLICKER PROBLEM

By: Doug Johnson

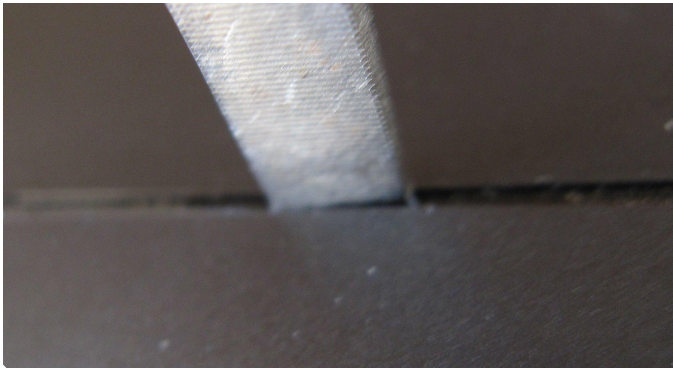
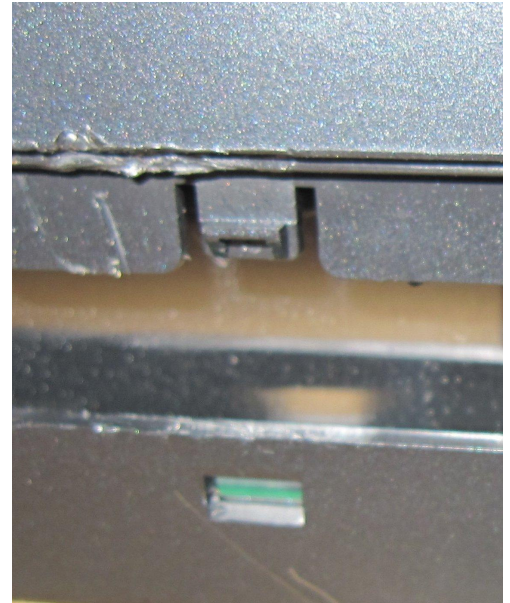
Start right underneath THE controls for brightness, contrast, menu etc. There's a small 2mm by 5mm square hole [green in the picture, but case color when you start]. Push in to release the tab [just above in the picture].

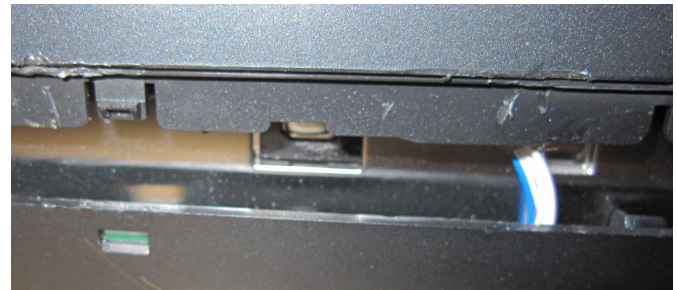
Then using a twisting and prying motion about every 1 inch separate the plastic monitor cover.

Work the bottom edge first, then right and left sides. Once bottom & right & left are free, put the monitor on a hard surface face down. Do not separate more than 1 cm else you'll pull the connector off controls assembly

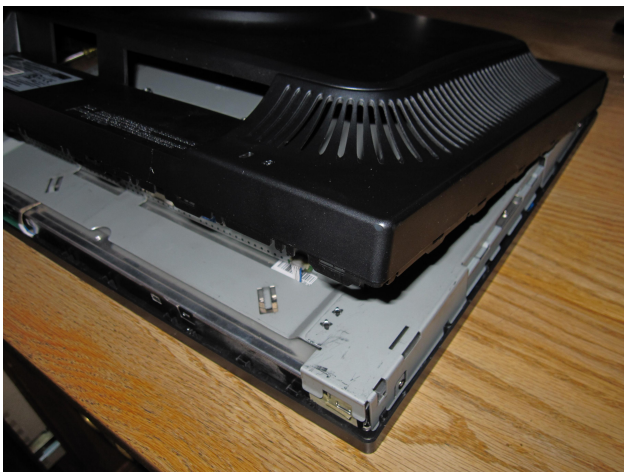
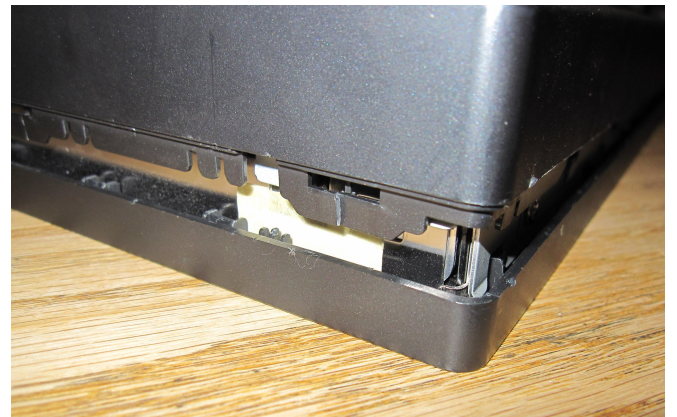
With the monitor face down as shown, carefully lift the back half of the plastic case off of the monitor away exposing the rear metal shield.

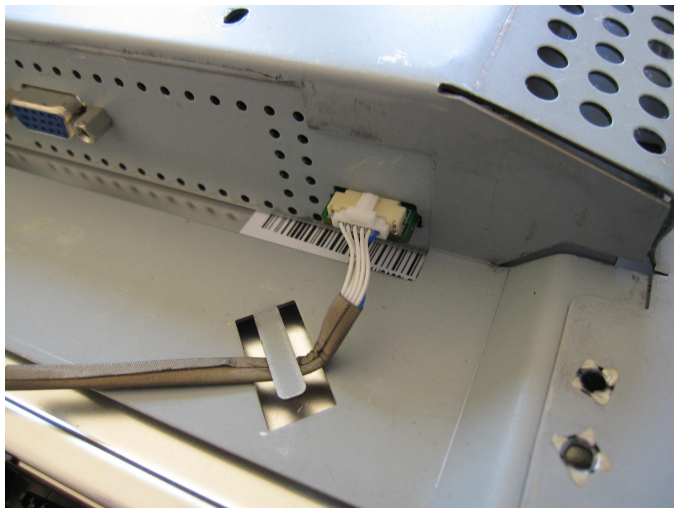
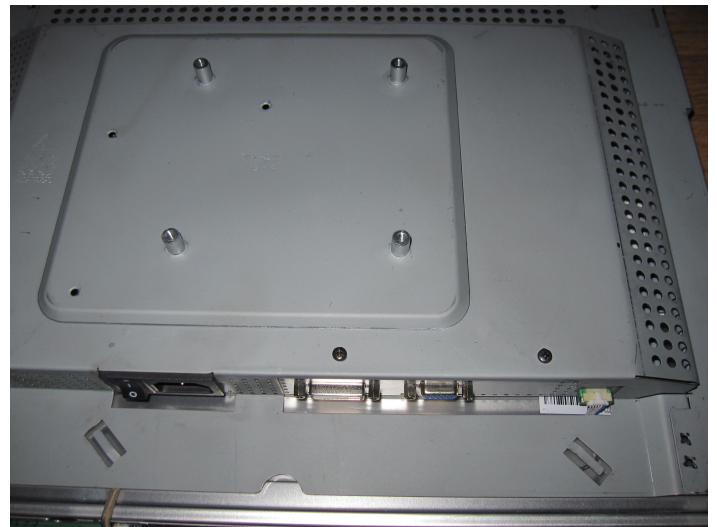
2A] Remove two screws on top

2B] Remove controls connector

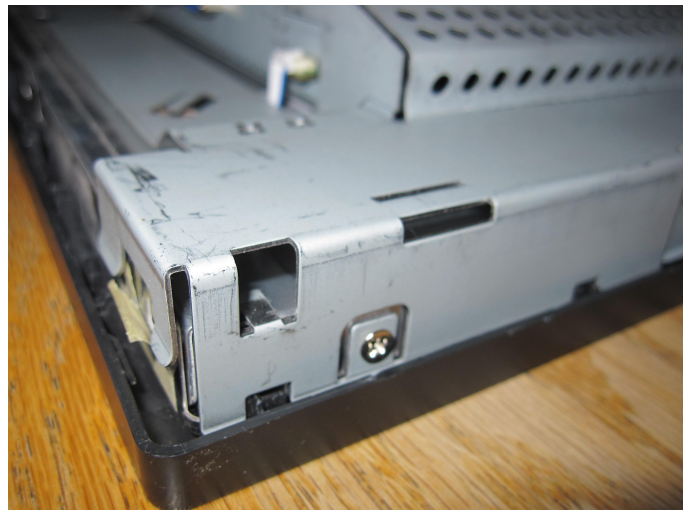
3] Remove 4 screws on sides

Pull the metal cover up and off.
